# Naval Station Everett Small Craft Piers Delta and Echo replace or repair analysis with recommendations

**Naval Station Everett  
Small Craft Piers Delta and Echo  
Replace or Repair Analysis  
With Recommendations**

**Professional Project  
University of Washington  
Construction Management**

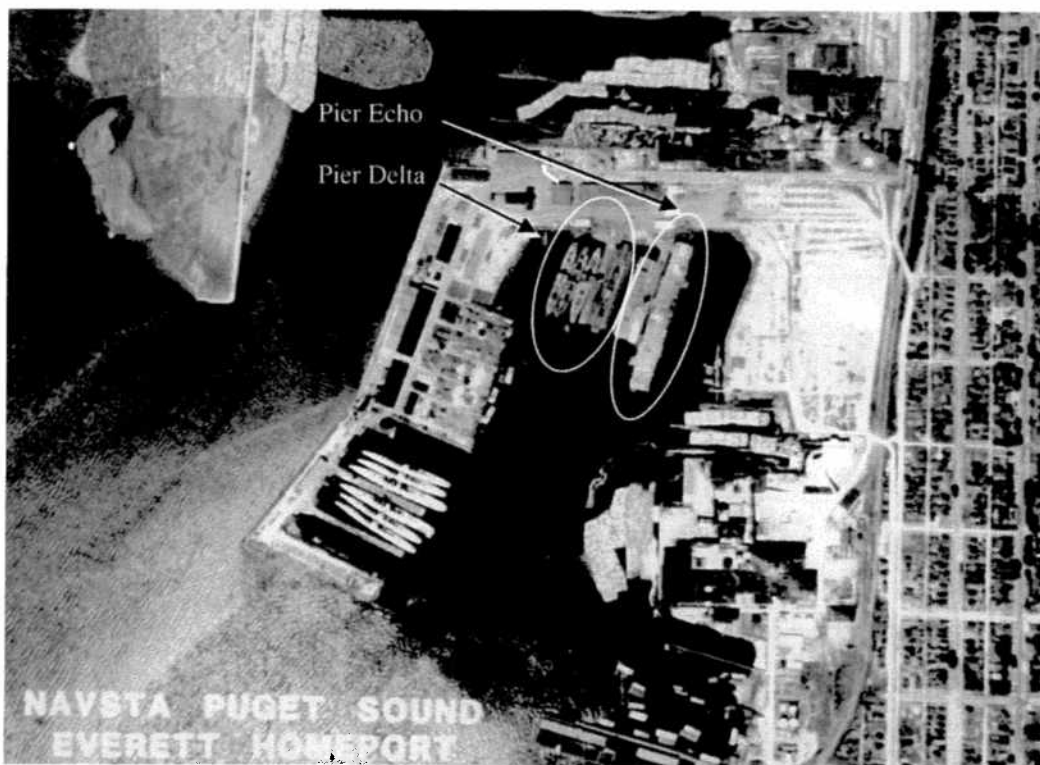
**Figure 4** – Aerial view of NS Everett, circa 1946

Piers Delta and Echo were originally constructed as aircraft carrier piers in World War II (see Figure 4). While records do not indicate exact time of construction, the piers' construction is accepted as circa 1941. The piers were constructed of a network of timber piles with timber pile caps and 18" x 18" timber decking. Given the 1941 construction timeframe, the two piers are nearly 70 years old. Their present condition shows their age and is of growing concern to Port Operations and the Afloat Training Group (ATG) who operate from the piers, as well as the base Public Works Department (PWD) who maintains them.

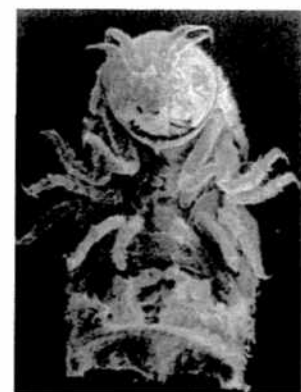
**Figure 8** – Gribble *Limnoria*

Section Four of this paper. Two species, the shipworm *Bankia* (Figure 7) and gribble *Limnoria* (Figure 8), now thrive in the East Waterway and consume the wood fiber of the timber piles that support the piers. The creosote exterior treatment on the piles has proved very effective in repelling the marine borers, though they have still penetrated the

piles through cracks in the exterior treated surface and consumed the wood material within pile interiors. Through this mechanism marine borer action has reduced the cross-sectional area of piles to anywhere between 50% and 90+% of their original area, greatly reducing their strength. The reduced

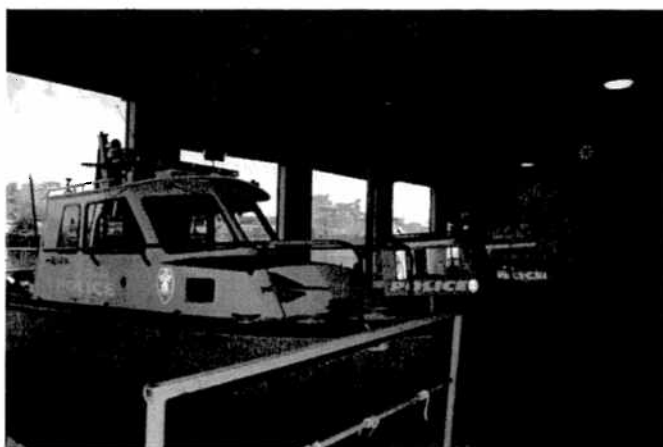
**Figure 9** – Security boats in boathouse at Pier Echo

Second, a floating boathouse located on the east, inboard side of Pier Echo houses all the security boats and increases the efficiency of pier side space. Further, the boathouse is covered and provides protection for the boats to reduce the boat maintenance burden (See Figure 9). The slips in the current boathouse, however, are too short to accommodate the current 28-foot security boats and should someday be replaced.

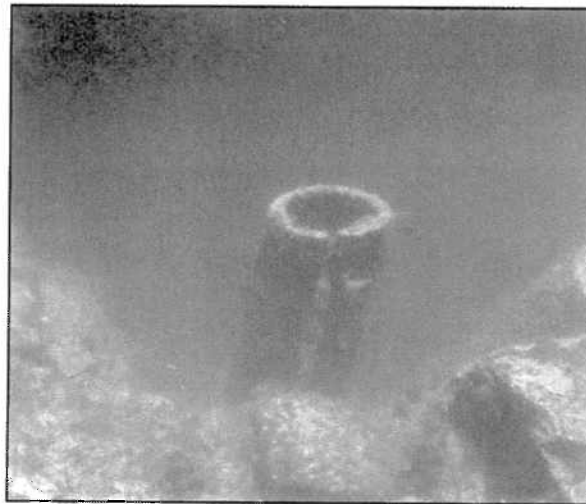
Berger/Abam also recommended that a representative number of pile wraps be removed to accurately determine the amount of internal deterioration that has occurred behind the wraps at mid-pile. Concern existed over the possibility of potentially higher levels of structural degradation inside wrapped piles. Destructive testing of piles was not conducted, however observations of existing piles that have been cut off above the mudline over past years show the extent of degradation that is possible (see Figure 16).

**Figure 16** – Sample pile demonstrating potential for interior pile degradation

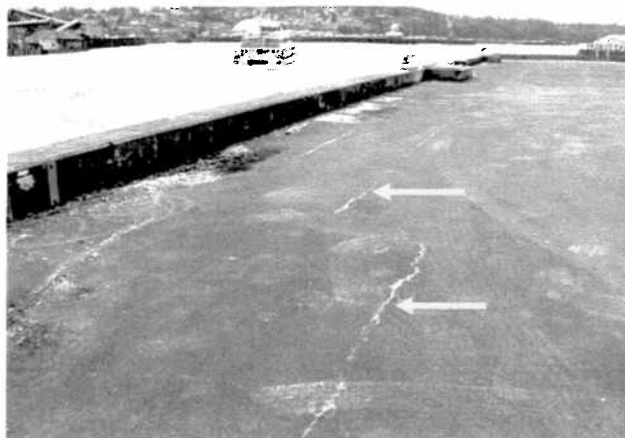
*Concrete decking (Delta)* – Overall good condition with minor surface cracks/defects.

**Figure 23** – Concrete surface cracks

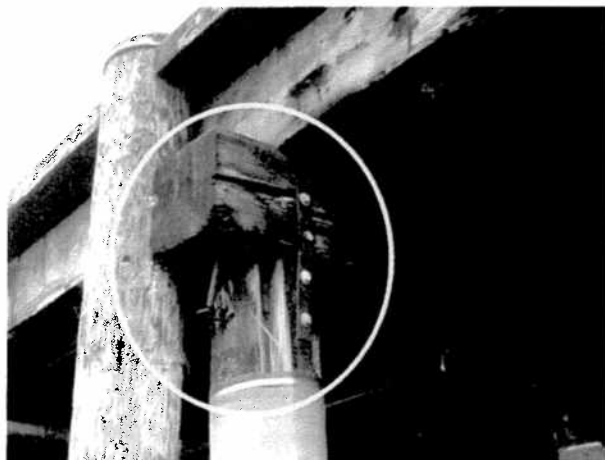
*Timber pile caps (Echo)* – Clearly deteriorating, with many misaligned piles and pile caps.

**Figure 24** – Splintered pile at pile cap interface

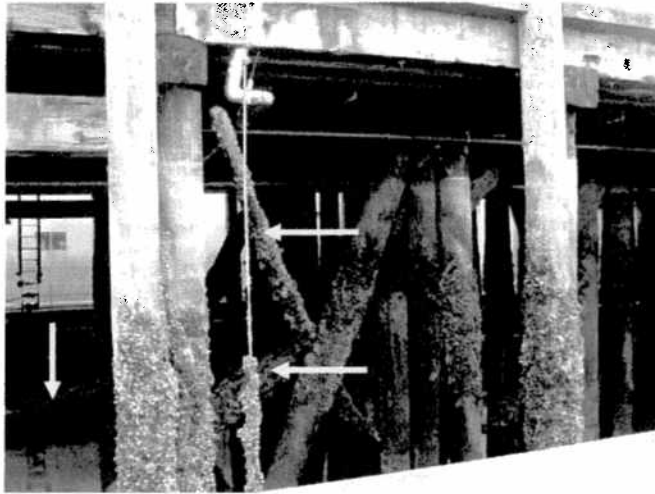
*Camels and debris* – Camels installed in past years have been ineffective and allowed debris into the pile network, causing damage to piles and wraps. All installed camels have sunk or otherwise no longer serve their intended purpose.

**Figure 27** – Debris under Pier Echo

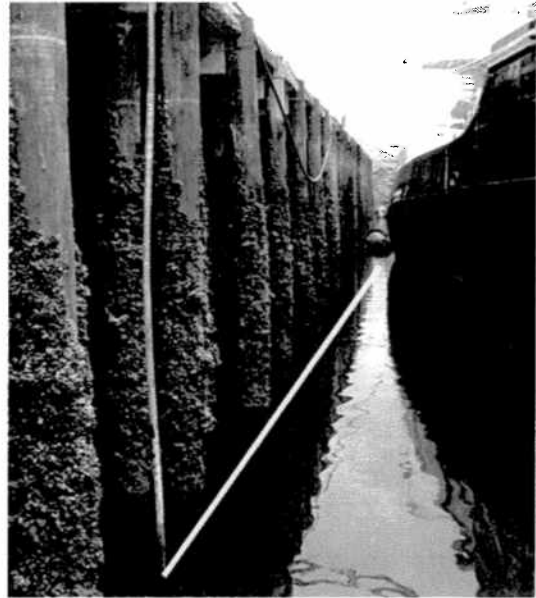
**Figure 28** – Missing camels along pier exteriors

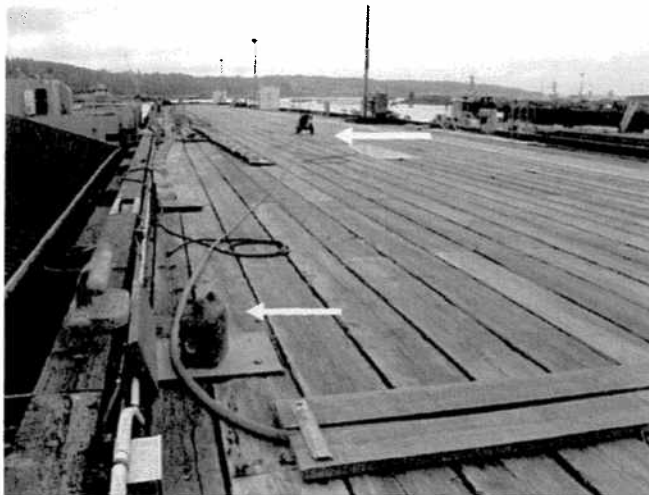
*Utilities* – Virtually nonexistent on the pier, forcing Port Operations to emplace temporary water lines and other utilities, as necessary. Functional electrical power runs to the office YFN on Pier Echo.

**Figure 29** – Temporary utilities on pier deck
